DEPARTMENT OF TRANSPORTATION

Contract #: 04-0120F4Cty: SF/ALA Rte: 80 PM: 13.2/13.9File #: 69.28**WELDING INSPECTION REPORT****Resident Engineer:** Pursell, Gary**Address:** 333 Burma Road**City:** Oakland, CA 94607**Report No:** WIR-008596**Date Inspected:** 24-Aug-2009**Project Name:** SAS Superstructure**OSM Arrival Time:** 1900**Prime Contractor:** American Bridge/Fluor Enterprises, a JV**OSM Departure Time:** 700**Contractor:** Zhenhua Port Machinery Company, Ltd (ZPMC), Changxing Island **Location:** Shanghai, China**CWI Name:** CWI: Zhan Bo**CWI Present:** Yes No**Inspected CWI report:** Yes No N/A**Rod Oven in Use:** Yes No N/A**Electrode to specification:** Yes No N/A**Weld Procedures Followed:** Yes No N/A**Qualified Welders:** Yes No N/A**Verified Joint Fit-up:** Yes No N/A**Approved Drawings:** Yes No N/A**Approved WPS:** Yes No N/A**Delayed / Cancelled:** Yes No N/A**Bridge No:** 34-0006**Component:** Tower components**Summary of Items Observed:**

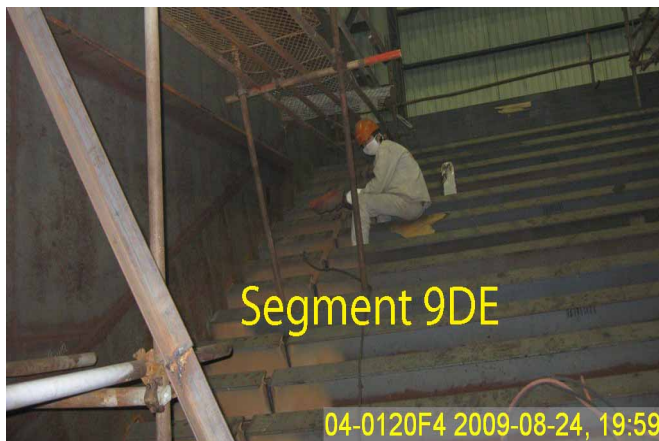
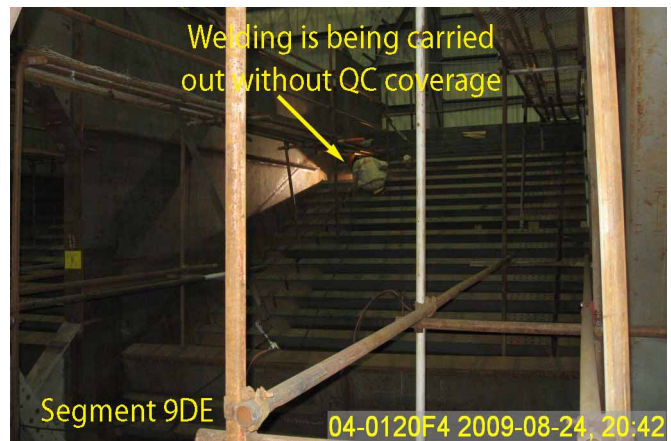
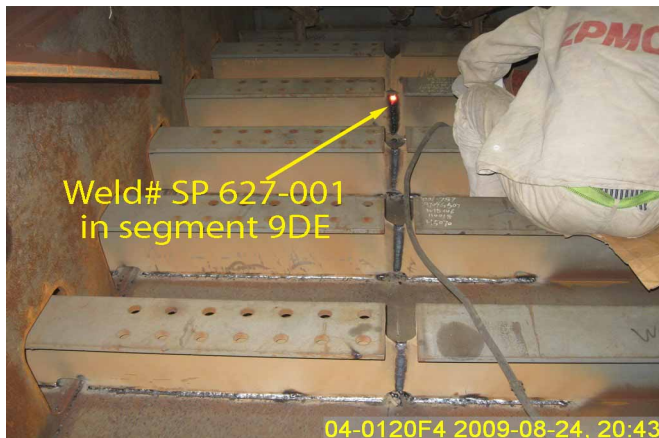
This Quality Assurance inspector (QA) observed the contractors welding personnel perform welding joint# identified as SP 627-001 on OBG segment 9DE in Bay# 14. The contractors Quality Control inspector (QC) was not present to monitor the weld parameters for more than 45 minutes. The QC inspector was busy in other area. No CWI was also available in the shop during this period. This QA Inspector has issued an incident report.
